## Tube support plate clogging up of French PWR steam generators

*Herve BODINEAU & Thierry SOLLIER*

IRSN - Reactor Safety Division

**Abstract:** Between 2004 and 2006, three primary-to-secondary leaks occurred at the Cruas NPP: unit 1 in February 2004 and unit 4 in November 2005 and February 2006. The three leaks were all the result of a circumferential crack in the tube at the location where the tube passes through the uppermost tube support plate (TSP #8).

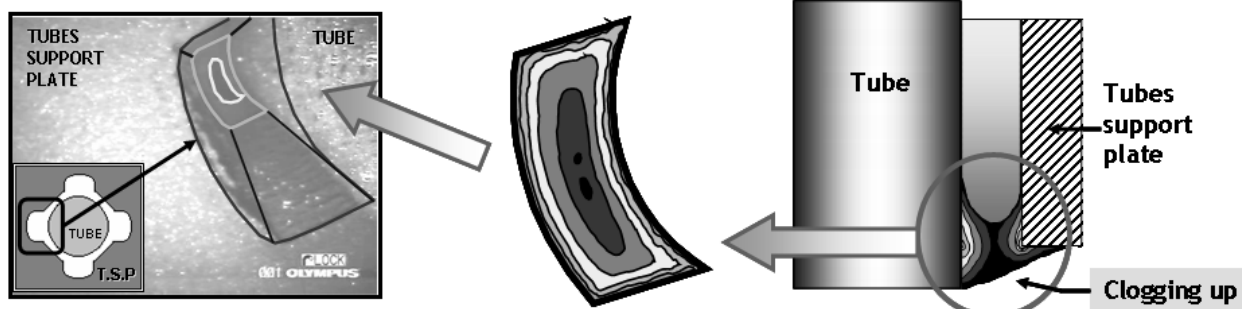
The results of in situ examination initiated by the Cruas NPP operator showed that the flow holes of the uppermost Tube Support Plates (TSPs) were partially or completely blocked by corrosion products. This phenomenon is referred to in this paper as TSP “clogging-up” and it was considered potentially generic for EDF NPP fleet. For the Cruas leakages, it was established that the association of TSP clogging-up and the specificity of the Cruas steam generator (central area in the tube bundle where no tubes are installed) were responsible for a significant increase in the velocity of the secondary fluid in the tube bundle central area. The high velocity of the fluid in this region increases the risk of fluidelastic instability for the tubes. Based on this preliminary analysis, EDF has implemented preventive measures (stabilizing and plugging of tubes in the central area of the tube bundle deemed sensitive to high cycle fatigue risk).

Picture of the opening between the tube and the T.S.P.

Pic. # 2: Representation of the clogged quadrifoil-shaped holes in the TSPs

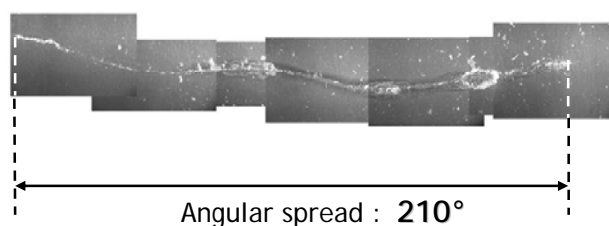
Continuous monitoring of primary-to-secondary leaks led to three shutdowns at the Cruas NPP: unit 1 in February 2004 and unit 4 in November 2005 and February 2006. Analyses carried out by EDF, further to the last two events, resulted in them being attributed to high cycle fatigue of steam generator tubes due to flow-induced vibration.

The phenomenon of cracking due to high cycle fatigue of U-bend tubes not supported by an Anti-Vibration Bar (AVB) was highlighted as early as 1987 (tube rupture in the NORTH ANNA 1 plant) and 1991 (MIHAMA). The tubes which leaked at Cruas were all located in raw 8 and were not supported by AVB by design. They were not considered sensitive to high cycle fatigue. A new fact caused the leakages observed on the Cruas units: the heavy build-up of deposits on the secondary side of the steam generator which changed the flow conditions in the center of the tube bundle. The deposits reduced or blocked water/steam flow through the quadrifoil-shaped holes in TSPs, forcing more water and steam into the center of the tube bundle, which caused the excessive vibration of the tubes near the center of the tube bundle. This excessive vibration due to fluid-elastic instability resulted in fatigue cracking of the tube.

Pic. # 4: Crack of tube  
L008 C047 (Cruas NPP - Unit 4 - S.G. # 2)

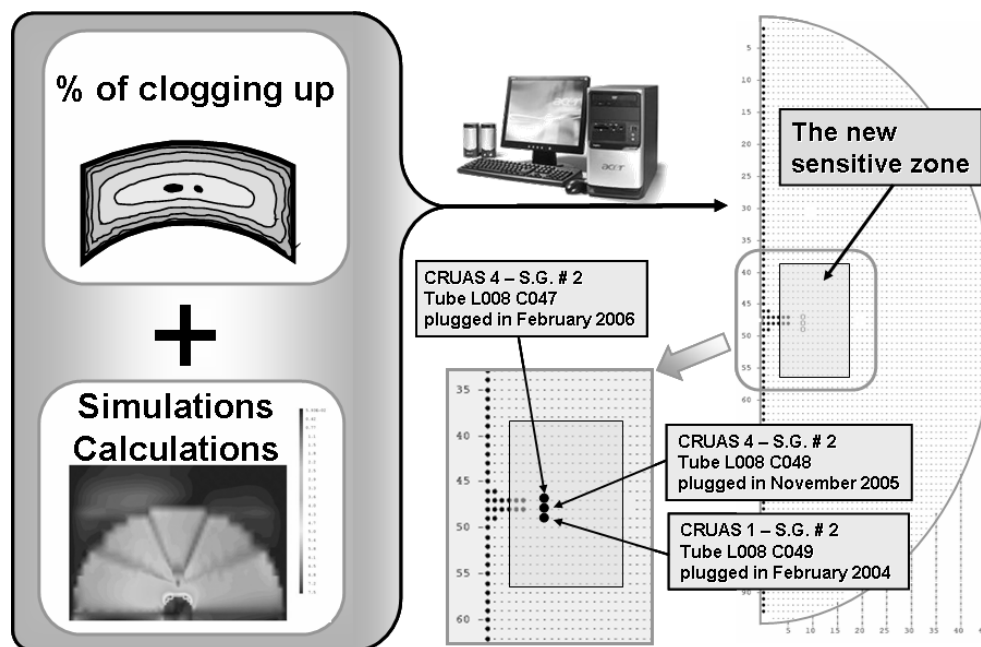
A specificity of the steam generators on the Cruas units is that they have a tubeless area in the central part. This area thus constitutes an easy path for the secondary system water. Moreover, due to its thermal-hydraulic effects, TSP clogging further increases the flow rate in this area and thus the vibration amplitude of the tubes (small U-bends) not supported by AVB. It is in this area that the previously mentioned tube cracking was observed. EDF then decided to take preventive action by plugging and stabilizing 58 tubes surrounding this area so that their potential degradation would not cause any primary-to-secondary leaks harmful to safety. This plugging was carried out for all the steam generators with the same design as Cruas.

Pic. # 6: Preventive plugging of 58 tubes

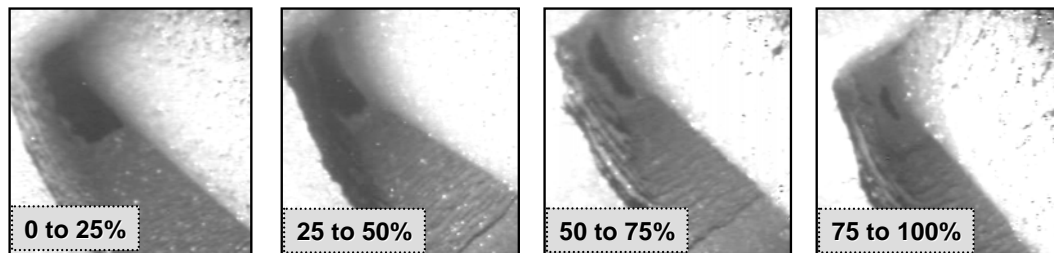
The initial inspections carried out inside the steam generators on the Cruas units showed significant clogging of the highest TSPs: on average, the cross-section of the quadrifoil-shaped holes was reduced by about 70% and some of them were completely blocked up.

Pic. # 7: Different rates of clogging up observed by EDF

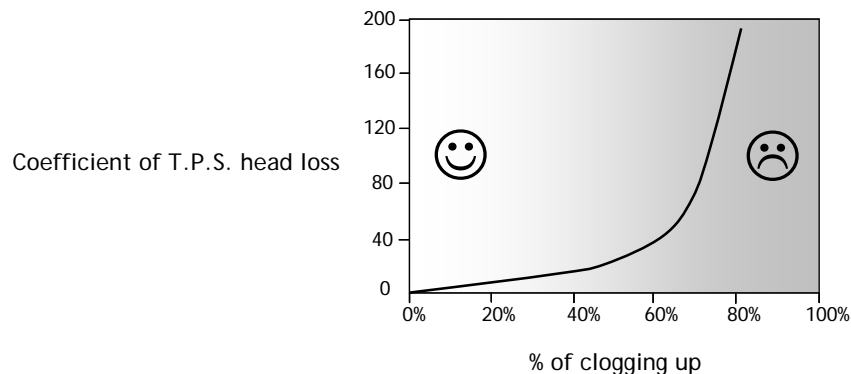
The clogging-up of TSPs results in greater resistance to water flows than considered at the design stage. Therefore TSPs and tie-rods could be subjected to heavier loads than considered at the design phase for transients.

**Pic. # 8: Correlation between clogging up % and TSP head losses**

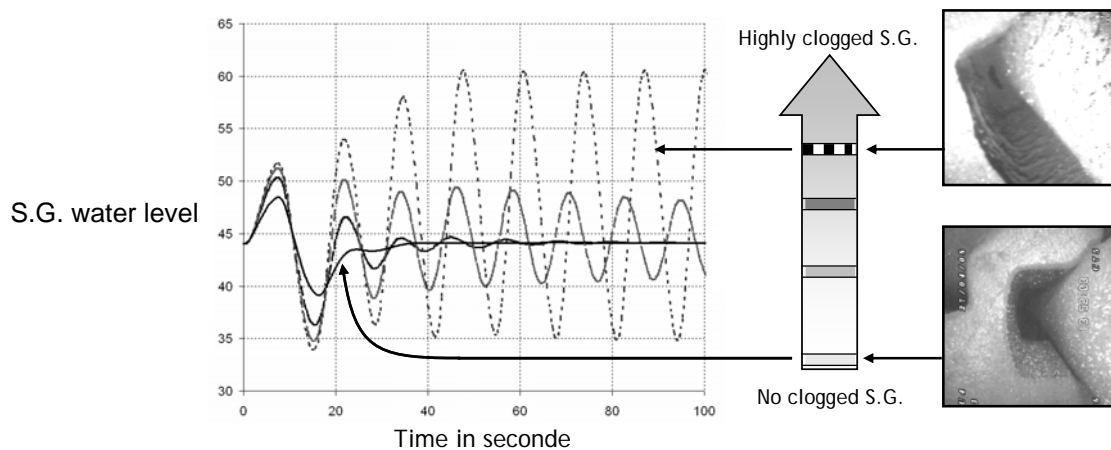
IRSN has also established a risk of water level oscillation by computation in response to a rapid transient such as a 10% power step (see picture #9).

Pic. # 9: Risk of water level oscillation in case of clogged TSP.

EDF has consequently reduced the maximum reactor operating power before the chemical cleaning of units:

- 1 and 4 of Cruas NPP (900 MW)  $\Rightarrow$  Power reduction at 80% of the nominal power,
- 1 of Belleville NPP (1300 MW)  $\Rightarrow$  Power reduction at 93% of the nominal power,
- 1 of Cattenom NPP (1300 MW)  $\Rightarrow$  Power reduction at 93% of the nominal power.

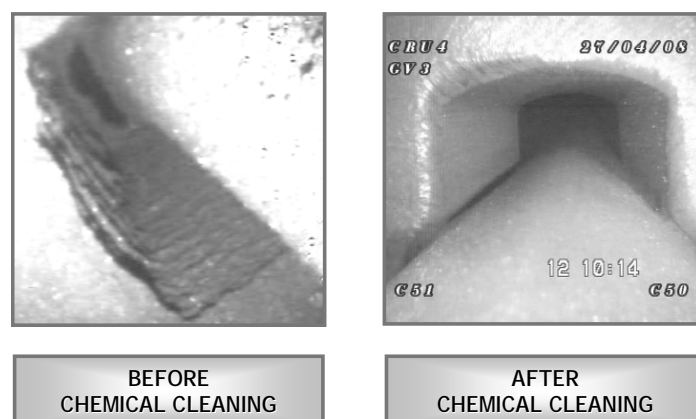
Given the analyses described above, ASN granted EDF authorization to carry out the chemical cleaning of steam generators on the units listed above in the table. These operations took place in 2007 and 2008. Based on eddy current testing and direct visual examinations, EDF considers that all the chemical cleanings were effective. However, IRSN considers that the operational feedback from both the implementation of the procedure and its impact on the plant should be analysed in details and used to optimize the next chemical cleaning.

Pic. # 11: View of a quadrifoil-shaped hole before and after chemical cleaning on Cruas unit 4

Such cleaning can be carried out with different procedures mainly based on chemical cleaning using reduction and sequestering of metal oxides using an appropriate solution. EDF decided to clean the most clogged steam generators in 2007 – units 1 and 4 of Cruas nuclear power plants and unit 2 of Chinon B for the 900 MWe series, and unit 1 in Saint-Alban for the 1300 MWe series. EDF opted at the beginning for an industrial process of chemical cleaning at high temperature. This procedure has been carried out a number of times on steam generators throughout the world as well as on unit 1 of Chinon B in 2003 to eliminate deposits on tubes. However, it is the first time that it has been used to eliminate clogging deposits on tube support plates.
